# Monitoring of Vodafone cellsites: annual summary 2018

Finalised: 31 August 2018

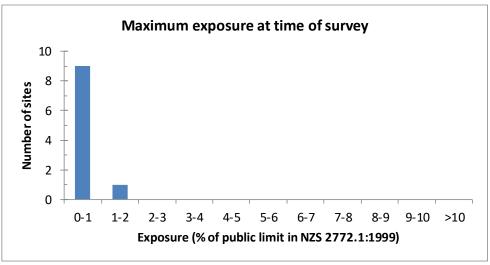
Figure 1 presents a histogram of the maximum exposure from all sources (ie from the Vodafone site of interest and any other transmitters) measured during the survey with the narrowband meter, at the ten sites surveyed in the period. Results are expressed as a percentage of the public limit in NZS 2772.1:1999.

Fig 1. Histogram of maximum exposures found at the time of measurement at the ten sites surveyed in 2018.

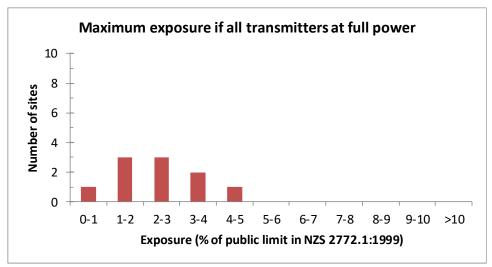
Figure 2 shows the maximum possible exposure at the ten sites, if all the Vodafone transmitters, and transmitters belonging to other cellular network operators nearby, were to transmit simultaneously at full power.

Fig 2. Histogram of maximum possible exposures at the ten sites surveyed in 2018, if they and all other sites nearby were to transmit at full power.

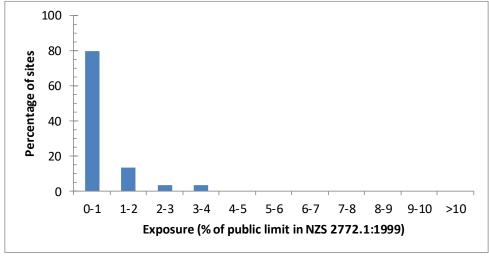
Figures 3 and 4 present the same data for all thirty sites measured over 2016, 2017 and 2018.

Fig 3. Histogram of maximum exposures found at the time of measurement at all thirty sites surveyed from 2016 to 2018.

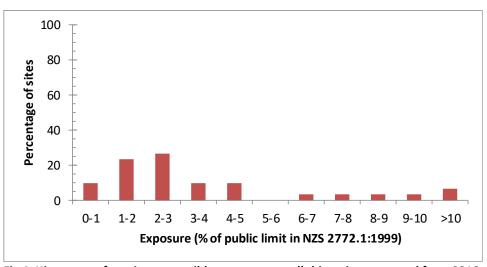
Fig 4. Histogram of maximum possible exposures at all thirty sites surveyed from 2016 to 2018, if they and all other sites nearby were to transmit at full power.
